DEPARTMENT OF ECOLOGY
INSPECTION REPORT

DATE OF VISIT: July 6, 1989

FACILITY: United Marine Shipbuilding, Inc. T R
ADDRESS : 6701 Fox Avenue, South MAP: 26 QUAD: B4
CITY: Seattle ZIP: 98108 COUNTY: King TEL: (206) 632-1441

TYPE OF FACILITY: Shipbuilding/repair
RECEIVING WATER: Duwamish River
TYPE OF TREATMENT SYSTEM: BMP's

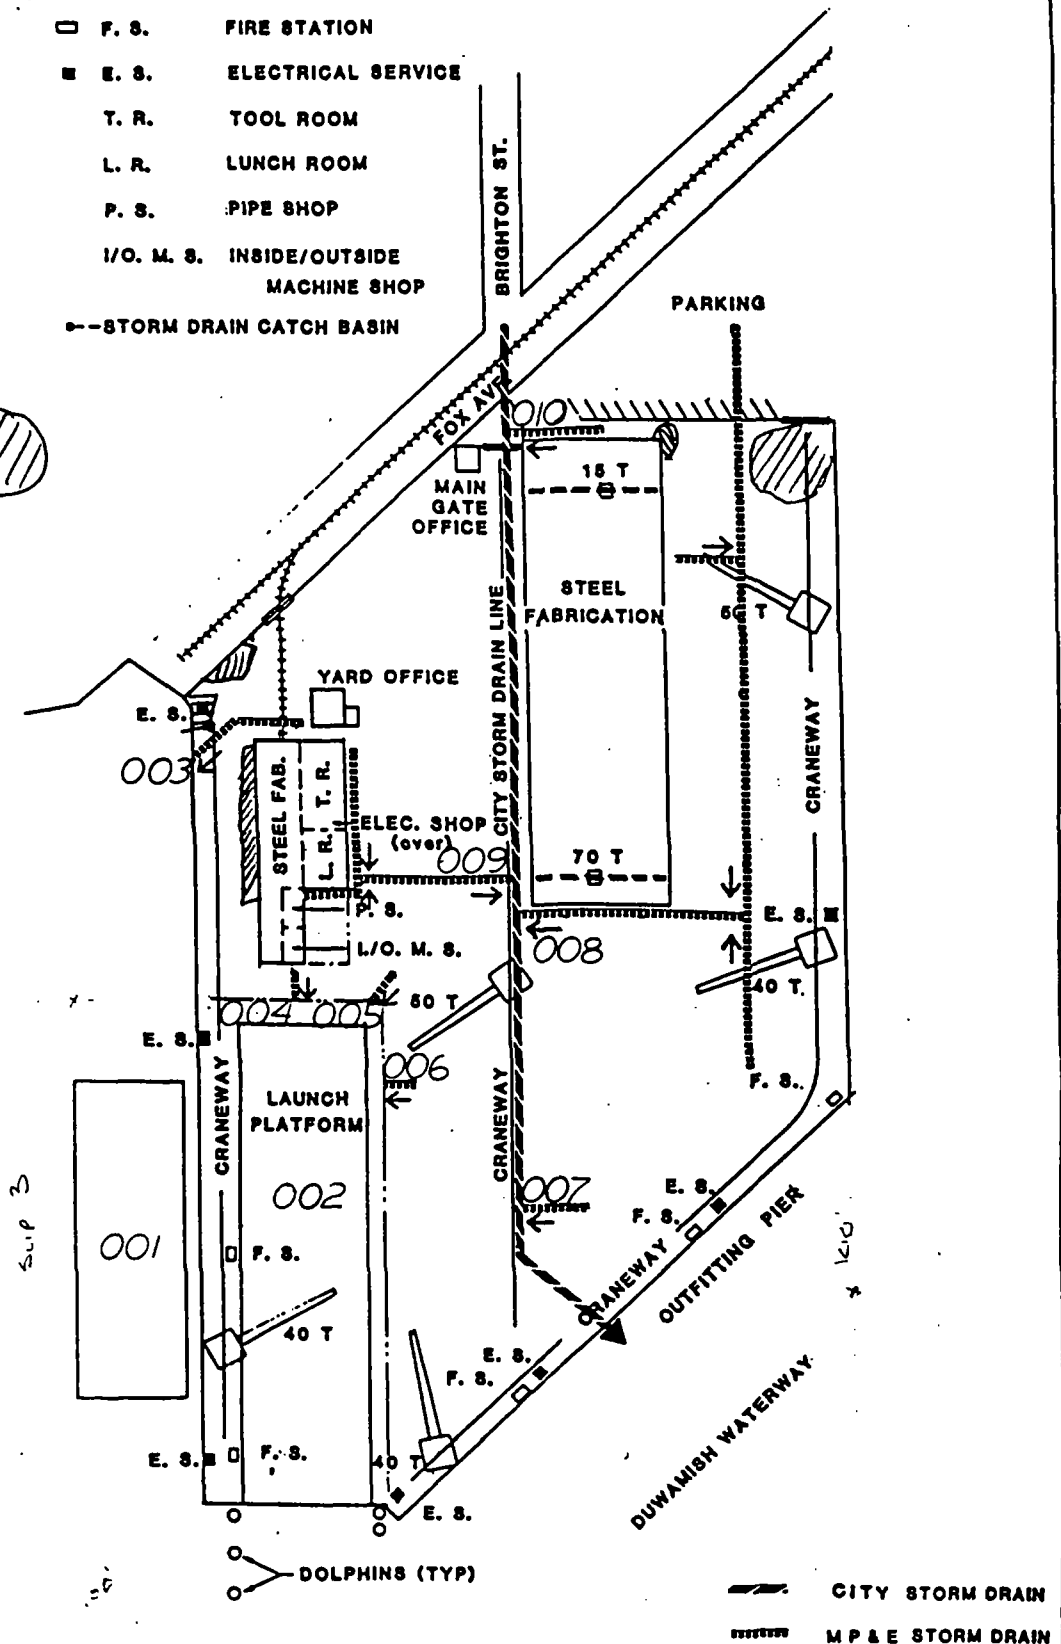
M P & E YARD 4 LAYOUT

Approximate area of soil contamination
